Research paper

Case study of exploited riparian corridors: rapid assessment of ecological health for riparian buffer width

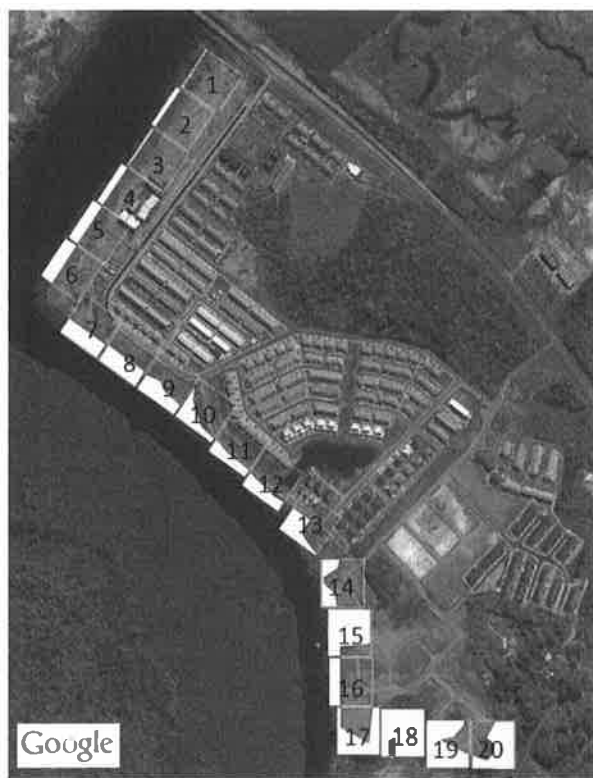
Figure 3 Vegetation cover in the study area.

It can be seen from the figures that the selected width was able to cover the activities along the river corridor. It is also clear that the main activities within each plot can be significantly reflected as human activities and vegetation cover. Based on this, the two attributes are the most convenient yet simple tools available for this study. Another attribute, the survival of wetlands dependent on watery habitats, has been identified and discussed at the end of this section.

The GIS model indicates that vegetation cover on average makes up only 39%, which is much lower compared to 61% of human activities. There are few plots that still maintain a high composition of vegetation cover, such as plots 15, 18, and 19. In stark contrast, plots 1 and 3 have less than 10% of vegetation cover due to human activities that include site clearing and soil compaction. These have caused major alterations to the riparian corridors.

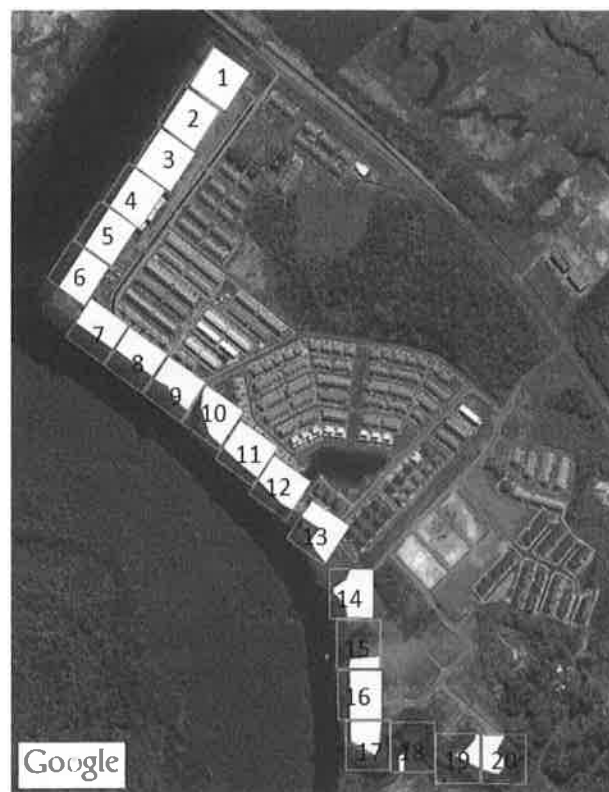
Figure 4 Human activities in the study area.

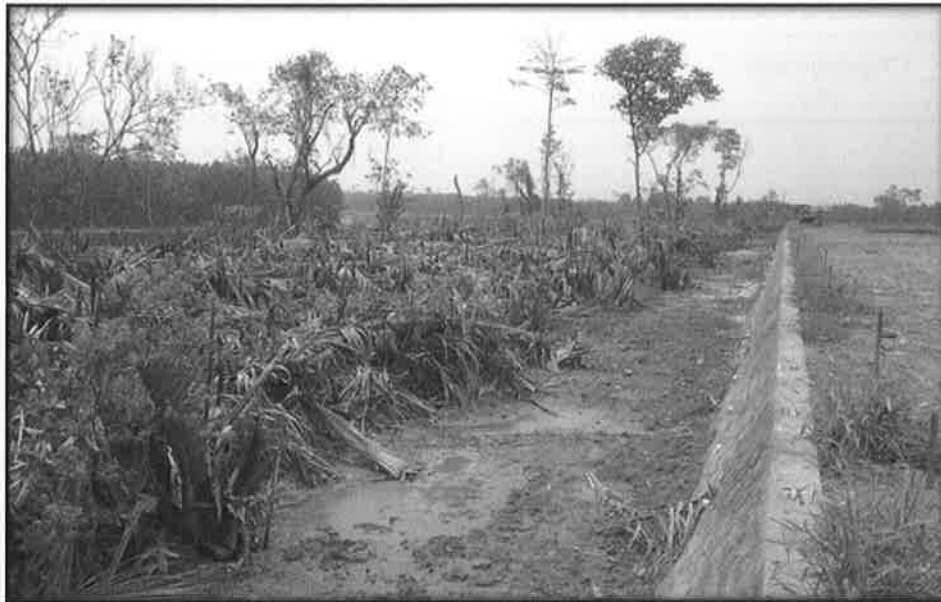
Figure 5 Condition of the nipah swamp at plot 5.

The above demonstrates that the higher the gradient of human activities, the more the riparian corridor degrades to non-functioning as showcased in plots 1–6. Because of the removal of vegetation cover, the soil cannot facilitate the capturing of water, resulting in a low groundwater table. This proves to be a disaster to hydrophilic nipah palms in general and other attaching wetland species (Figures 5 and 6). On the other hand, the higher the composition of vegetation, the more the plots remain as a functioning riparian corridor as in plots 17–20. The remaining plots of 7–16 have high groundwater levels, and yet high levels of human activities put the nipah swamp to intermediate; or in another words, at risk.

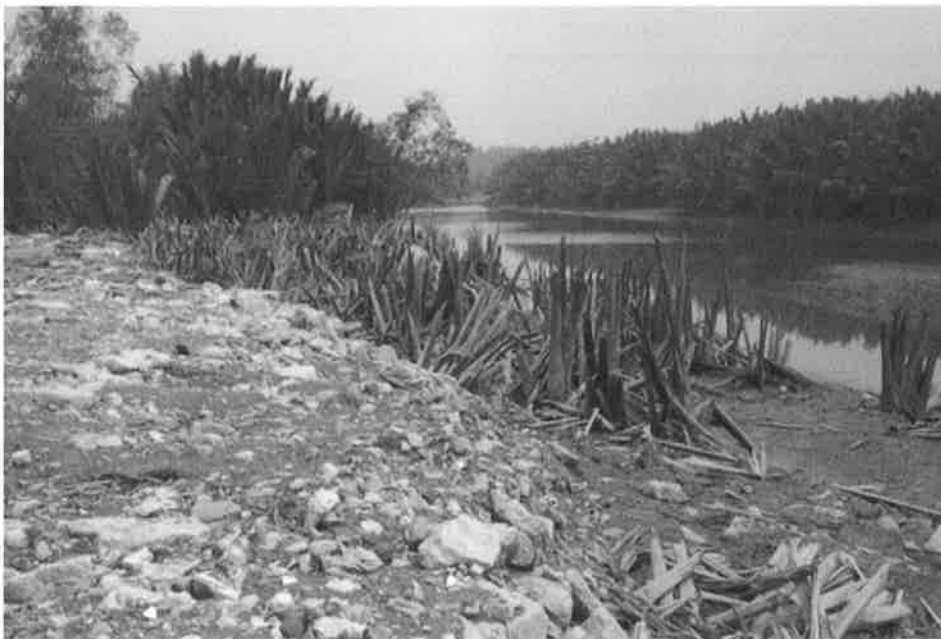
Figure 6 Condition of the nipah swamp at plot 11.
